Report No. CDH-DTP-R-82-10

WIND POWERED HIGHWAY SIGNS

Final Report
December 1982

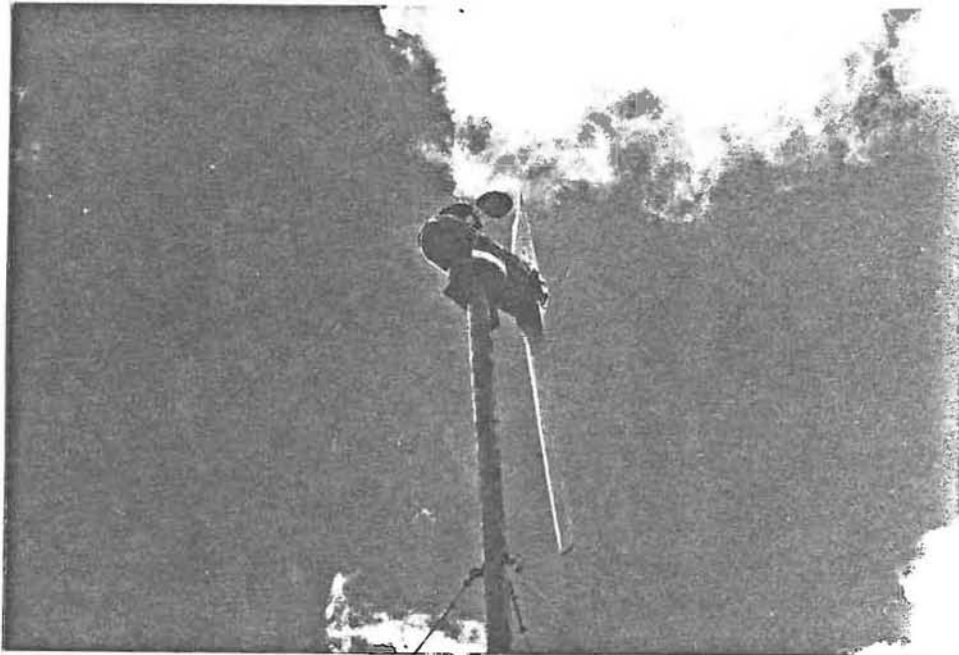
The generator failed at about 1:30 a.m. on June 18, 1982. This is established by a strip chart record which showed the generator generating power at the time of failure. The record also indicated that the wind at the time was strong and gusty. These weather conditions were corroborated by local citizens around Gunnison who gave information as to a storm passage during the night which blew over trees and caused roof damage to homes in the area. Photographs B-1 and B-2 show the generator as it appeared soon after the damage.

Damaged wind generator atop mounting mast. The yaw vane stalk is broken and yaw drive is free to move.

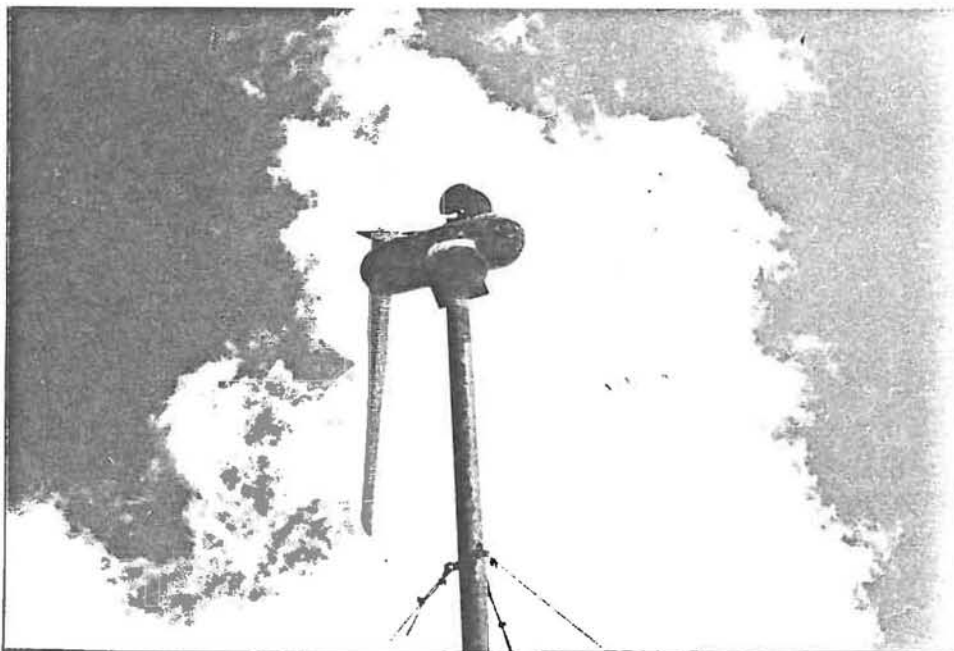
This view shows the yaw drive vane projecting into the plane of propeller rotation.

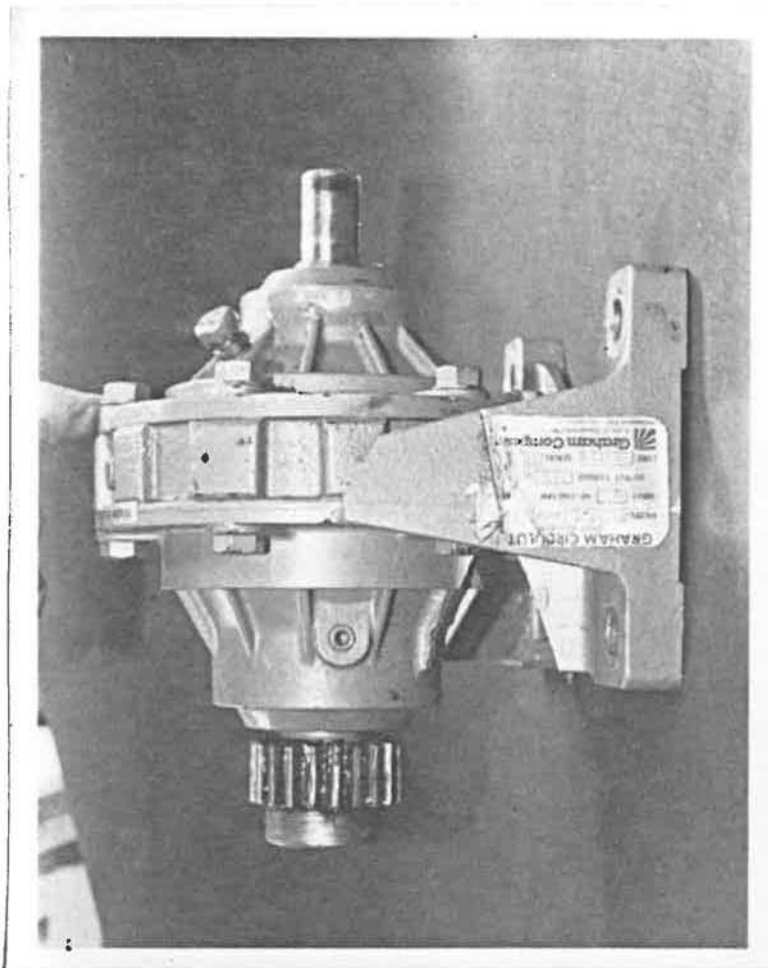
Yaw Drive Gear Box.
The yaw drive stalk is
attached to the shaft at top.
The gear at the bottom
meshes with a fixed gear on
the tower mount.

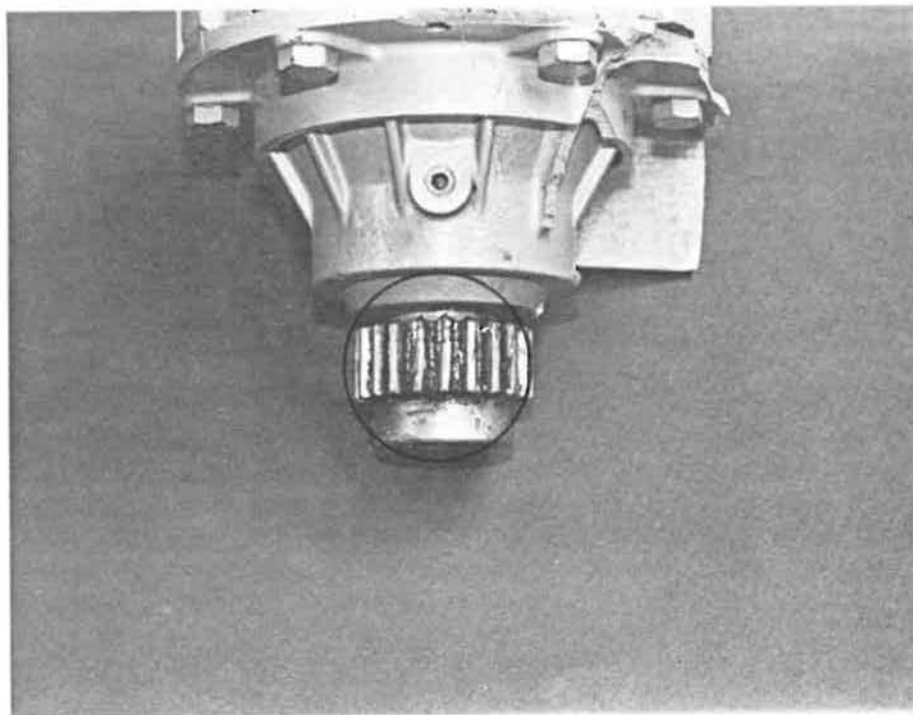
Damaged gear teeth on the yaw drive gear.

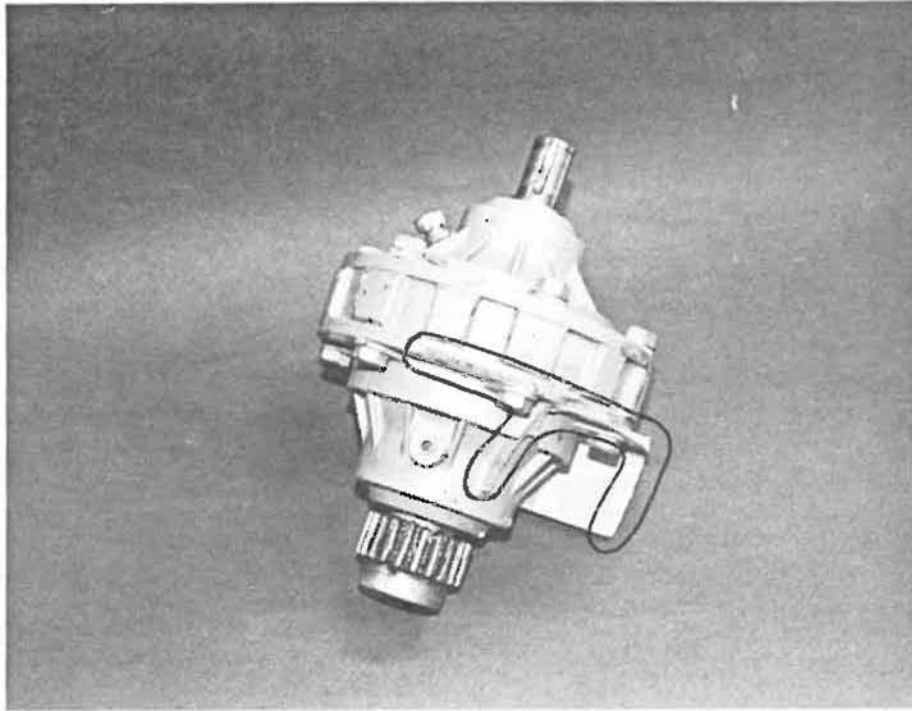
The major damage to the generator was the separation of the YAW DRIVE GEAR assembly from its mounting at the rear of the generator assembly. This could cause the damage to the other parts of the system. The other parts damaged were the propeller, a piece was broken off, and the pivot mast, which was bent. Photographs B-3 through B-8 show the damaged components after generator was disassembled.

dynamic forces on the yaw drive gear mounting. This mounting is cast aluminum, and is the most likely part to fail. With the failure of the yaw drive, the generator is free to swivel, and does not have any limit to overspeeding. With the propeller overspeeding, the blades and other components are subject to destructive forces.

Yaw drive gear box. The mounting flanges are broken off. The flanges are cast integrally with the gear housing. Fracture areas are outlined.

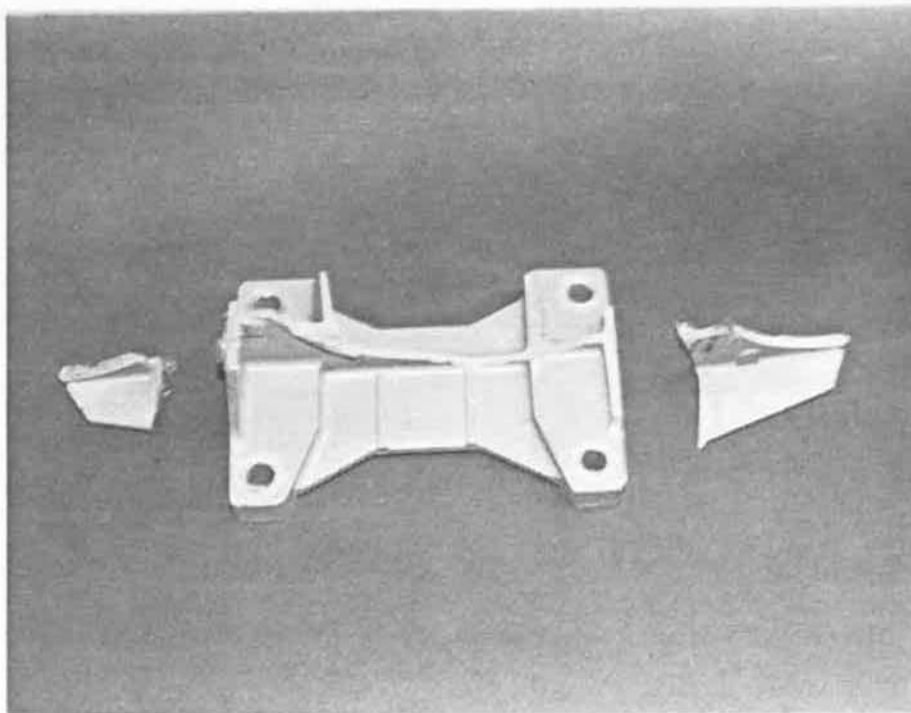
Fractured mounting flanges.

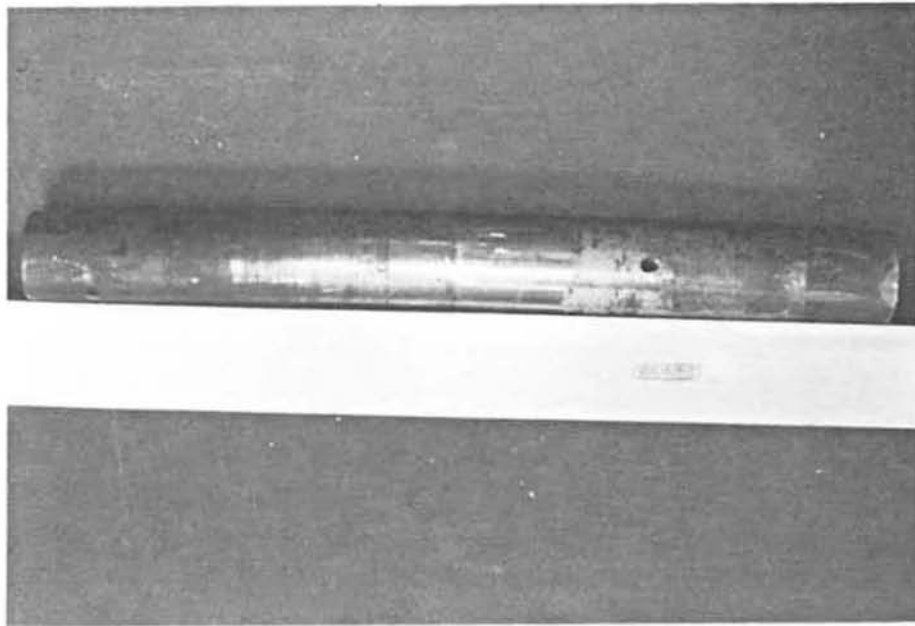
The main pivot shaft is bent. The straightedge indicates the amount of deformation.

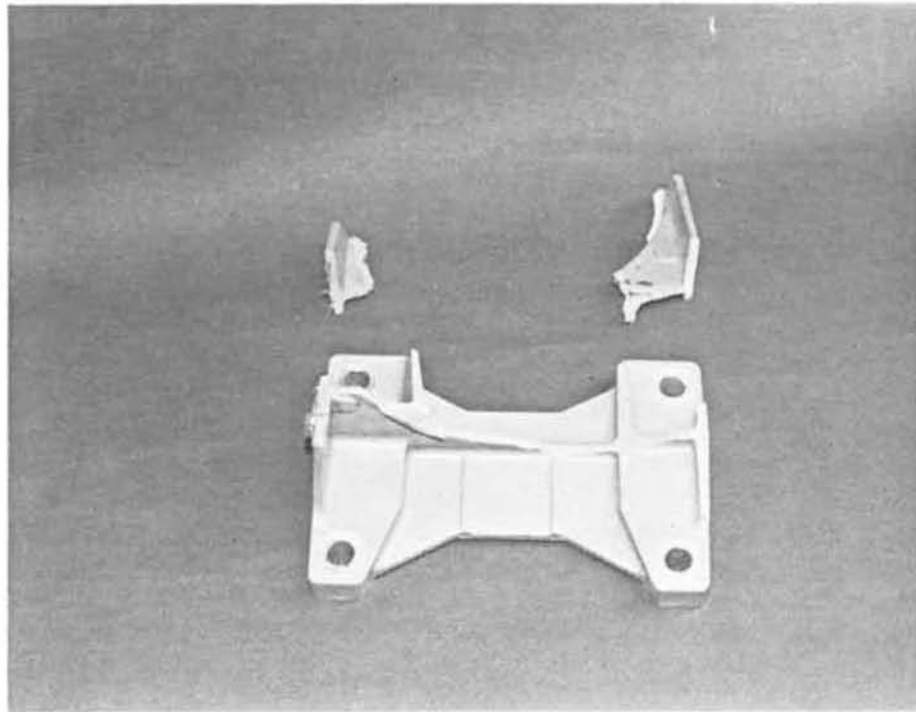
Fractured mounting flanges.

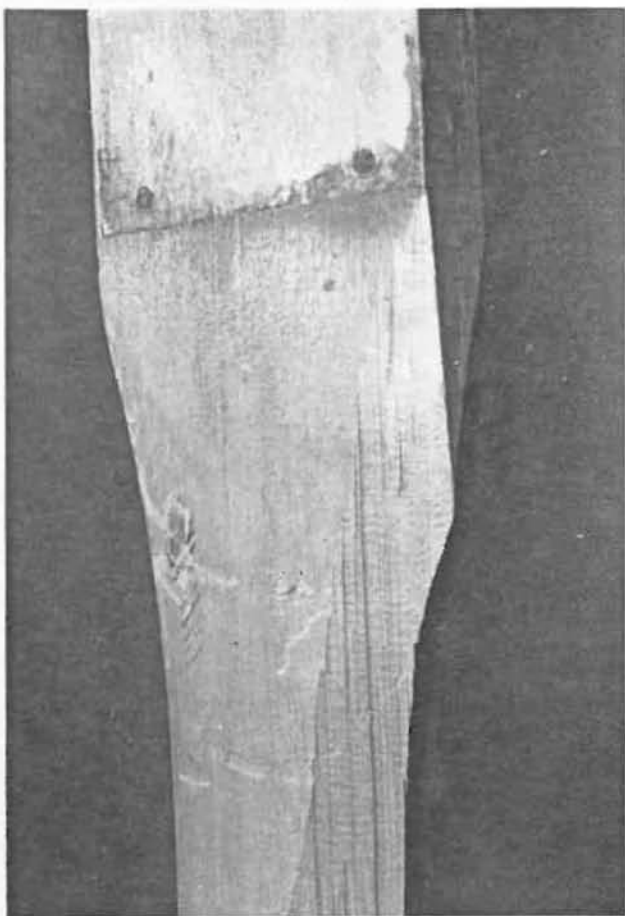
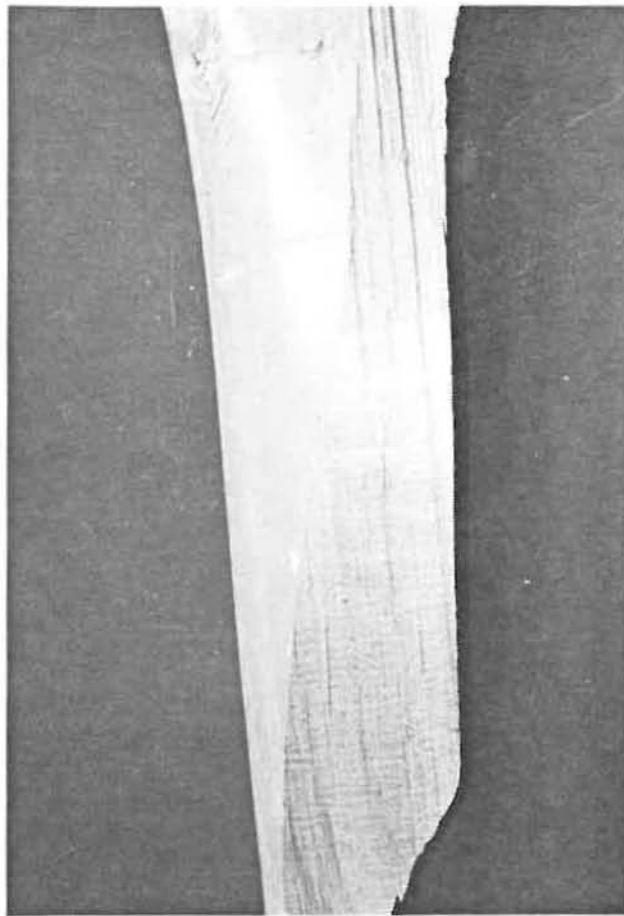
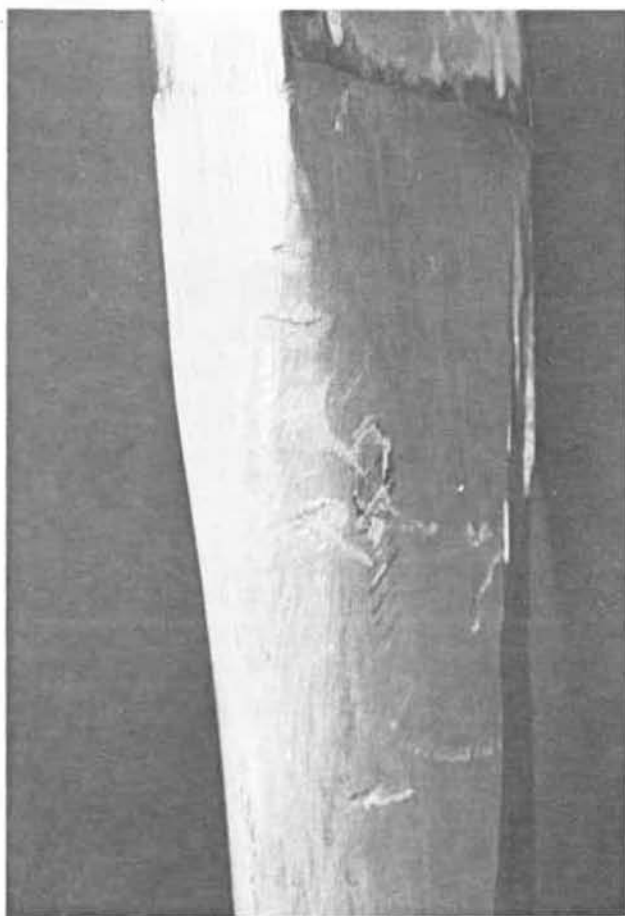
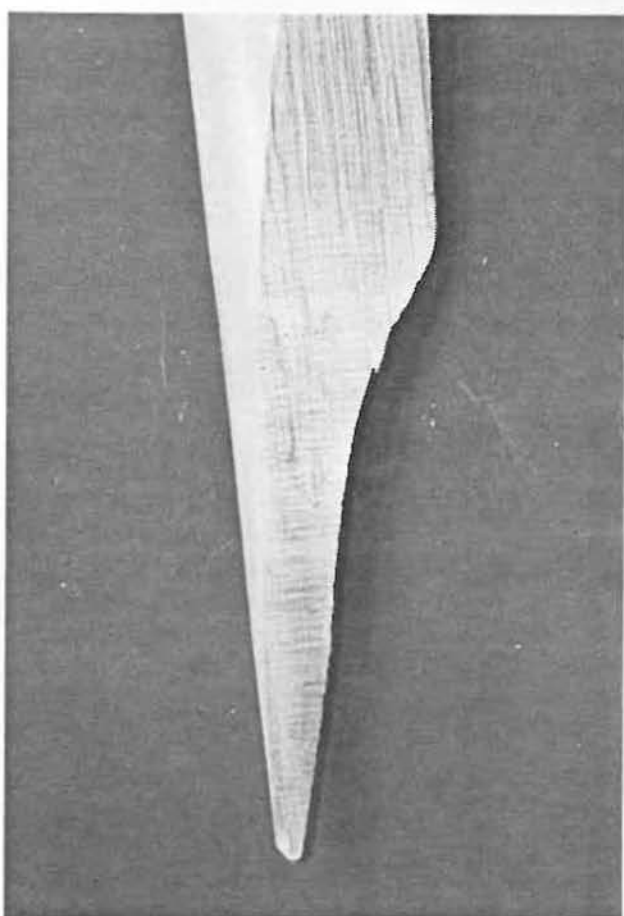
A third possible sequence, a foreign object, i.e., piece of wood, small pebble, etc., striking a propeller blade that is rotary at a high RPM, could cause failure of the blade resulting in the severe unbalanced condition and vibration in the tower structure as in the first sequence. The missing piece of propeller blade has not been recovered. Photographs B-9 through B-12 show the broken propeller blade stub.

Propeller damage and showing rotational marks on stub end of propeller.

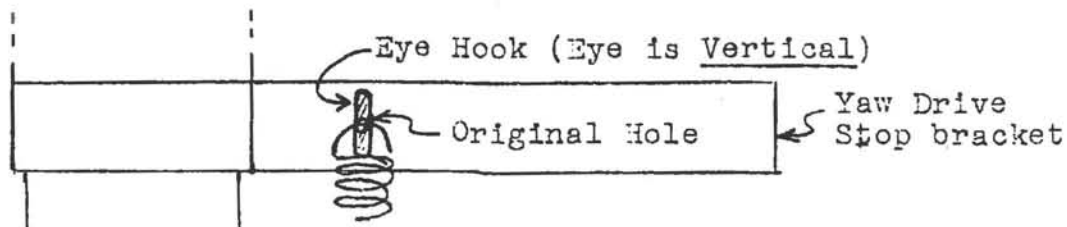
- 3) We sincerely regret that the yaw return spring replacement sent out with Service Bulletin Number 1 did not solve the breakage problem. The fault is corrected by modifying the attachment of the spring to the yaw drive assembly stop bracket per the figure below:

Remove and discard old spring. Mount eye hook in existing hole in the yaw drive assembly stop bracket with eye hook vertical. Jam nut goes on first followed by nylon insert lock nut. Tighten securely. Install new yaw return spring with square end in frame hole and round end in eye hook..
