Report No. CDH-DTP-R-82-10

WIND POWERED HIGHWAY SIGNS

Final Report
December 1982

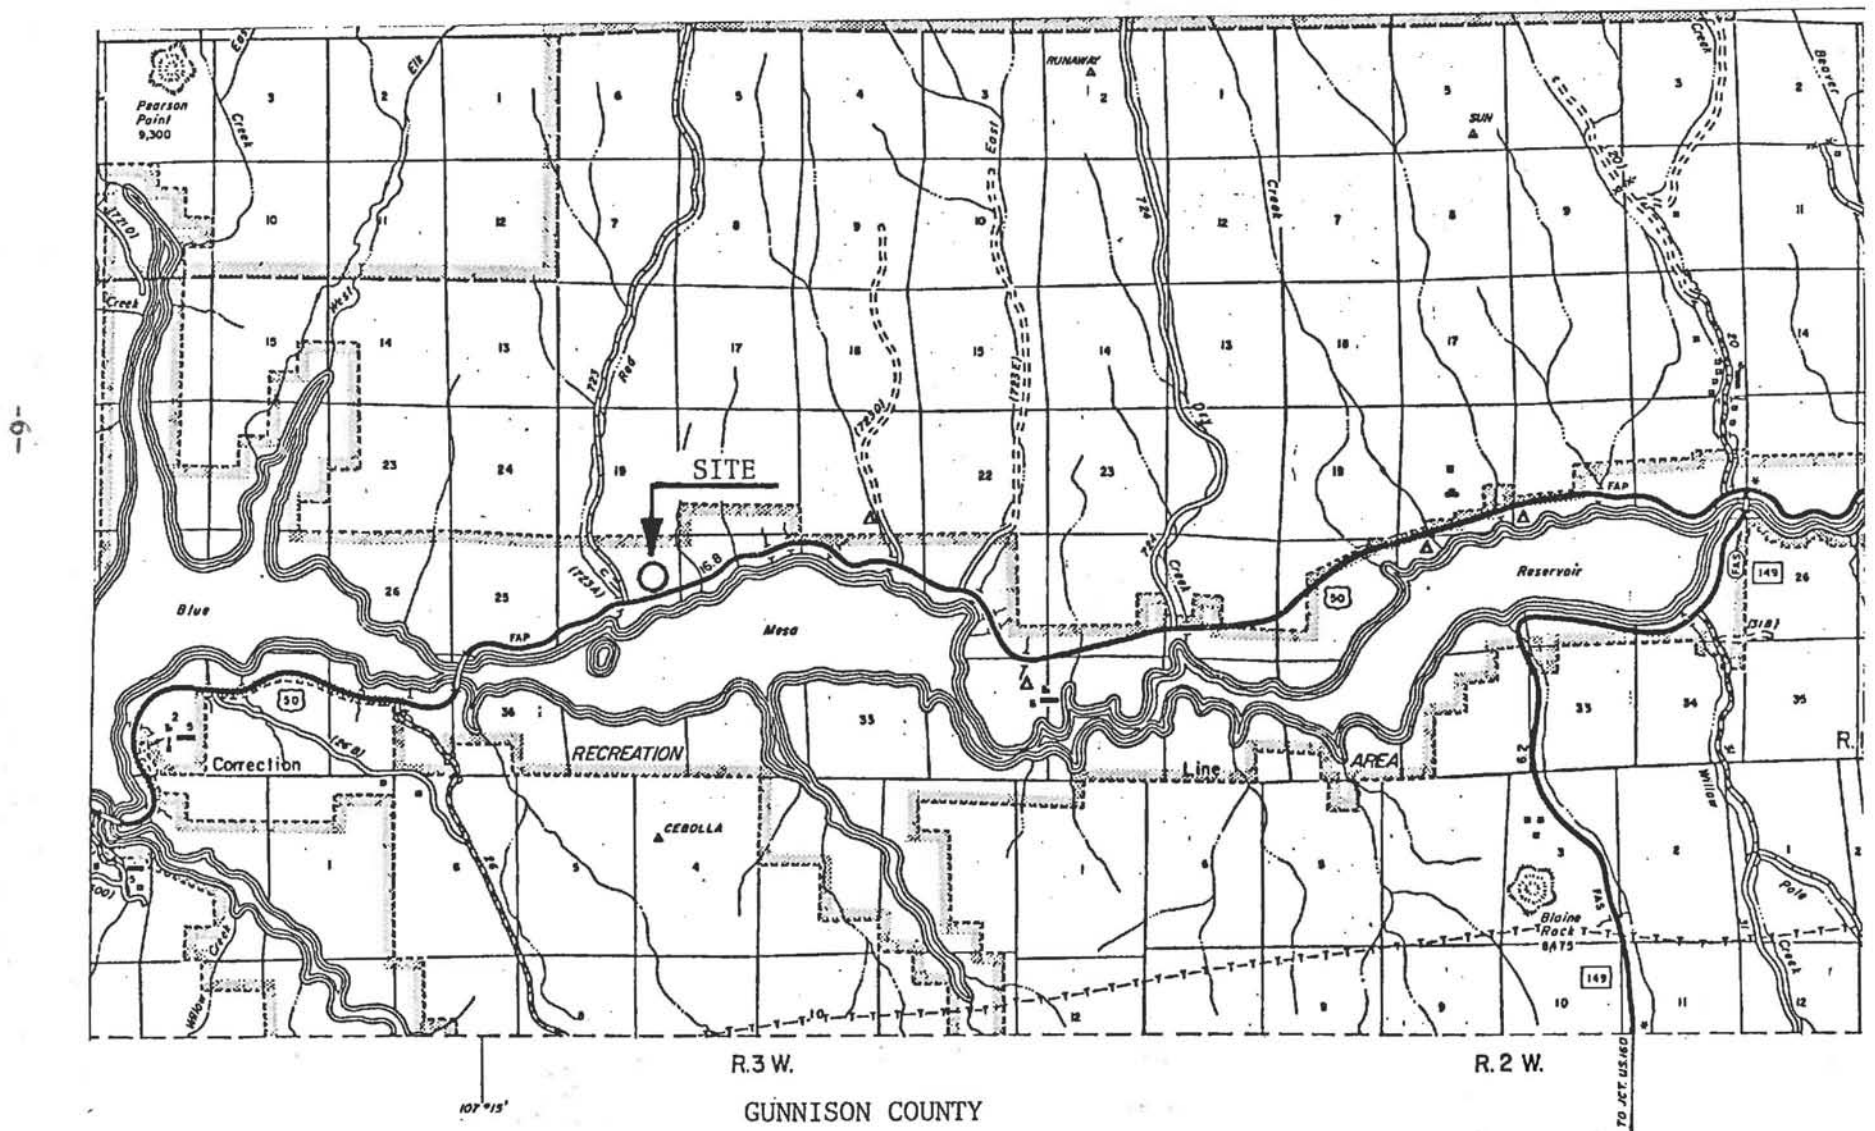
FIGURE 1

roadway. At this location, the generator would be practically unnoticeable from the roadway and the equipment building would not be visible from the roadway. See Figure 1.

WIND GENERATOR LOCATION

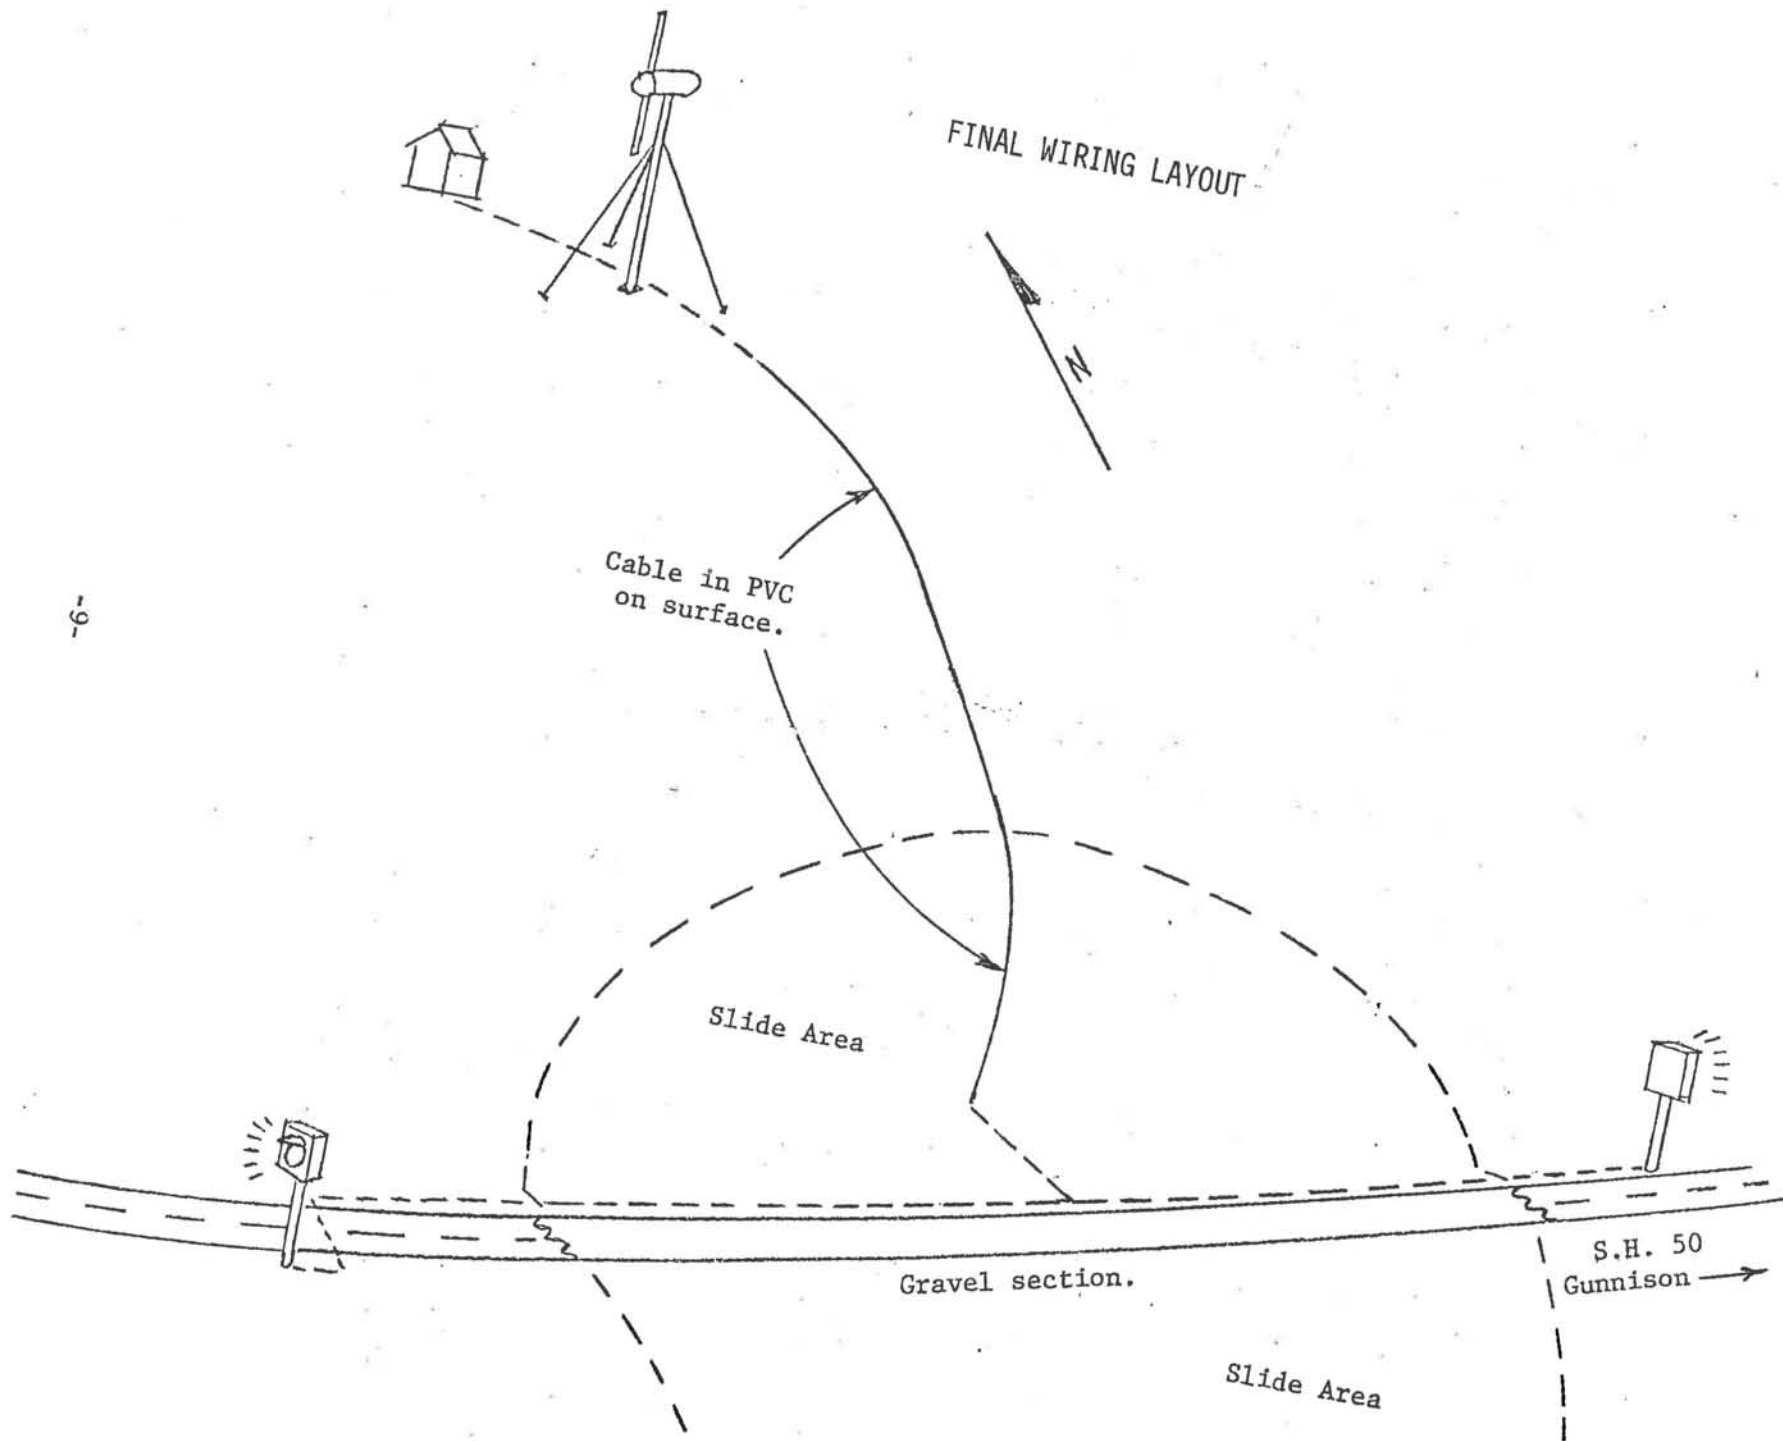
FIGURE 3

Several factors were considered in the wiring layout at this site. Since the site is located within the Curecanti National Recreation Area it was agreed between the National Park Service and the Colorado Highway Department that during installation at this location there would be minimal disturbance of the natural terrain. The soil at the site was very rocky and trenching by hand to bury the cable would be almost impossible. Use of trenching machinery would be unacceptable due to damage to the ecology. The cabling from the wind tower to the battery/control enclosure was laid on the surface and covered with 1"-2" of soil. The cabling from the wind tower to the lights was placed in a PVC Pipe and laid on the surface for about 100'; then the conductors were laid on the surface as shown in Figure 2. Due to local code requirements the cable runs were later changed as shown in Figure 3.

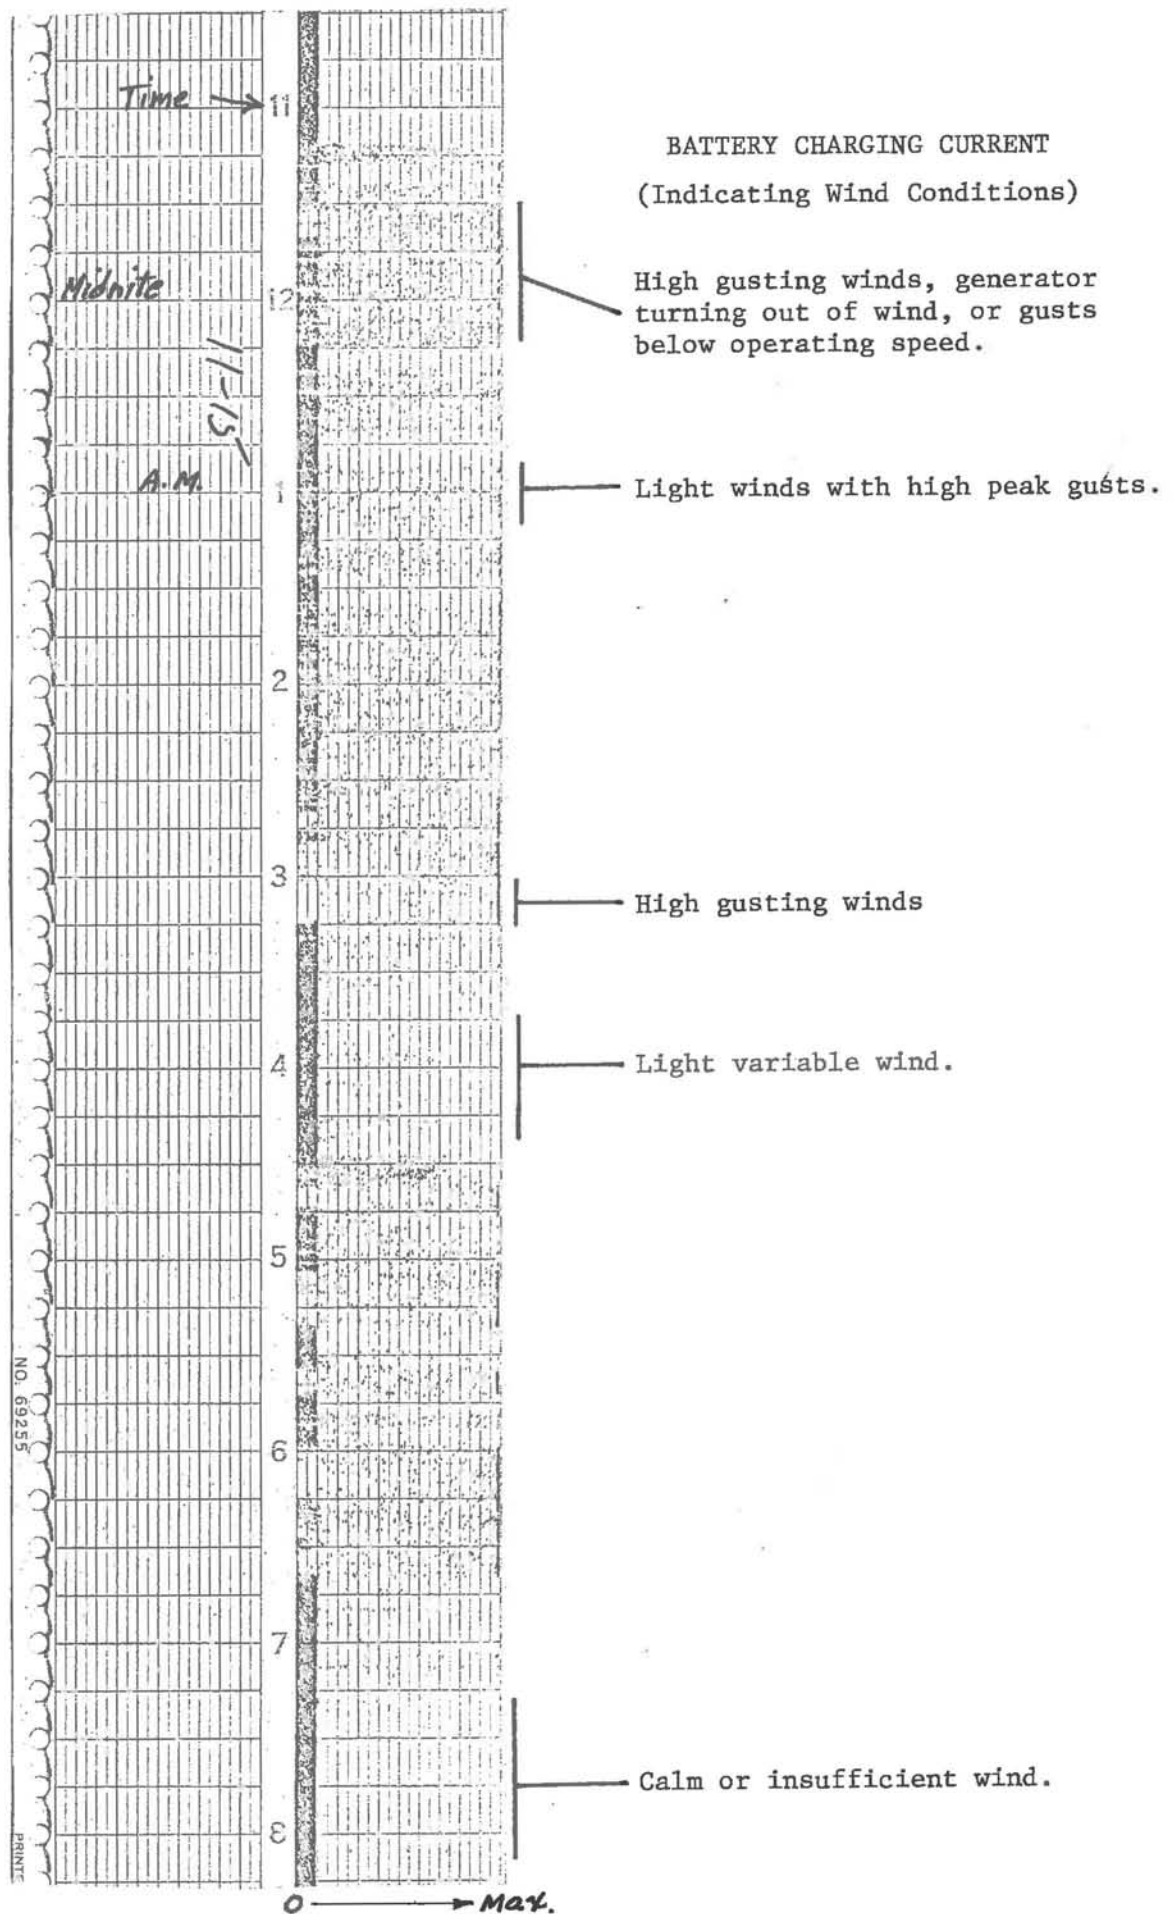
Figure 4.

A Rustrak chart recorder was used to collect data on wind generator performance. The recording ammeter would reflect battery charging current, indicating that sufficient power was being generated to operate the flashing lights and charge the batteries. A sample chart reproduction is shown in figure 4. The chart record also indicates wind condition as it affects the operation of the generator.

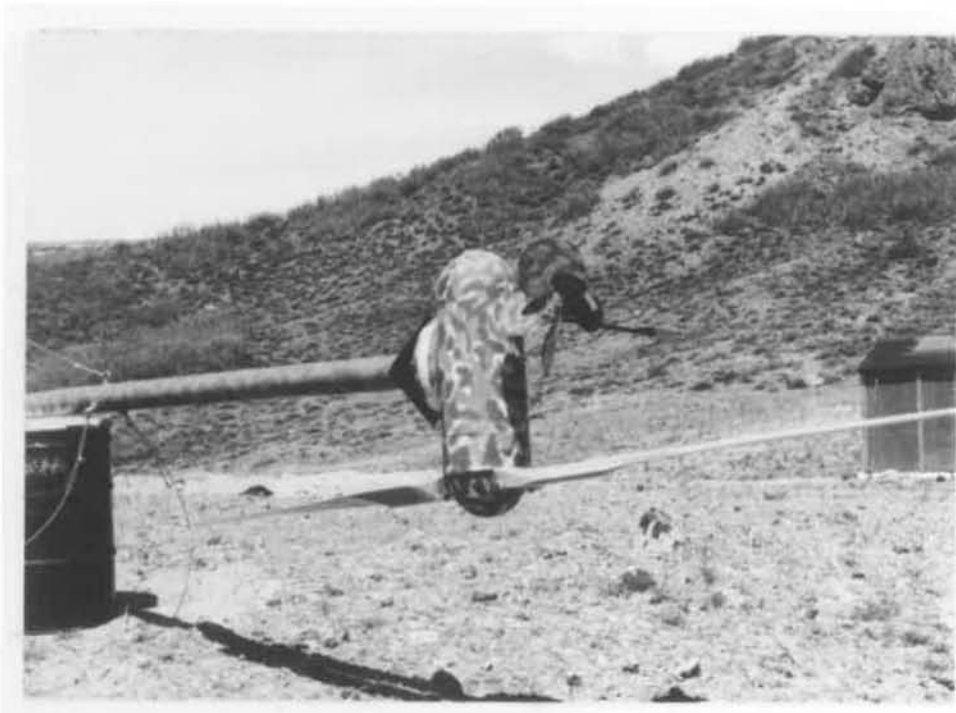
Tower lowered to allow servicing of the generator.

generator. Replacement parts had to be obtained from the Whirlwind Power Company in Denver and the mast had to be lowered to correct or replace the spring and this resulted in additional "down time". Approximately four hours were required to lower the mast, correct the problem, and raise the mast again. A minimum of three persons is required to raise and lower the mast safely.

4. Easy access to the wind generator atop the supporting mast is necessary for this type equipment in order to reduce the down time required for maintenance and minor repair. Climbing steps mounted on the supporting mast would provide this easy access if adequate measures are taken to minimize access to unauthorized persons to prevent vandalism.
